## Crosley Radio Project

John B. Gilmer Jr. August 2, 2025

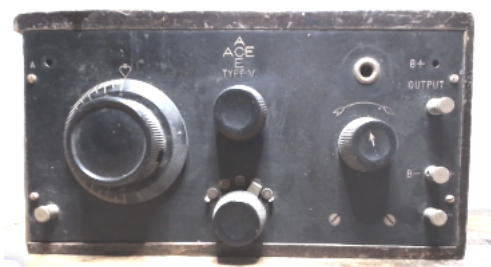
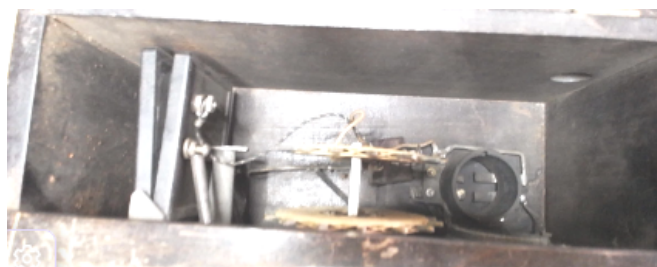
1. **Ace Type V** (serial number 9492): This is a single tube radio with just the detector stage. The binding post for the antenna (upper left corner of the faceplate, marked "A," is missing. So is the binding post for the "B+" connection, in the upper right corner. The "Output" connector is loose, and the bus bar inside the radio from this terminal is loose. The controls (Capacitor, tuning selector, rheostat, and regeneration) all seem to all be functional. The vacuum tube is missing. There are no obvious other problems, but this is merely a superficial visual inspection. (It is possible that the missing terminals were used to repair other radios.)

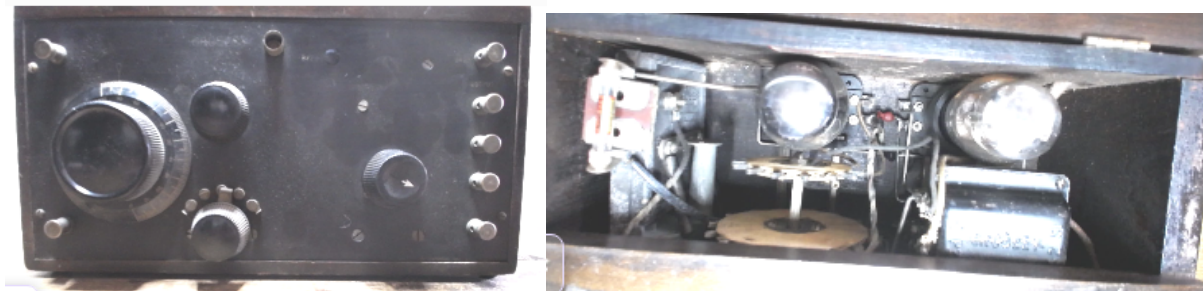
2. **Crosley 51**: This is a two tube radio, with an initial detector stage similar to the radio above, followed by a transformer coupled single stage amplifier. The cardboard identifying square giving a serial number is missing. This particular radio is unique among the five in having a socket for a small incandescent light bulb in the upper middle of the front panel, mid-way between the A and B+ terminals. Nearby and to the right is what seems to be a sealed hole in the front panel labeled "B22+" where, presumably, a terminal once was. Was this a factory modification or adaptation, or a user improvisation? I don't know. The four controls, with the same functions as those of the Ace V, all seem mechanically functional. Inside, there are no

loose wires except a cord with four conductors (red, white, yellow and black) led out of the radio through a hole of ½ inch diameter in the back panel. The hole looks like it may have been original. These wires presumably connect to the A and the B batteries. The two tubes could not easily be extracted from their sockets, and have been left in place for now. (Determining which tubes are present is important, since the type 51 can be used with tubes of varying filament Voltages. Thus, the radio needs correspondingly different A battery power sources ranging from 1 ½ up to 6 Volts, and possibly B+ variations.) Nothing seems to be visibly missing.

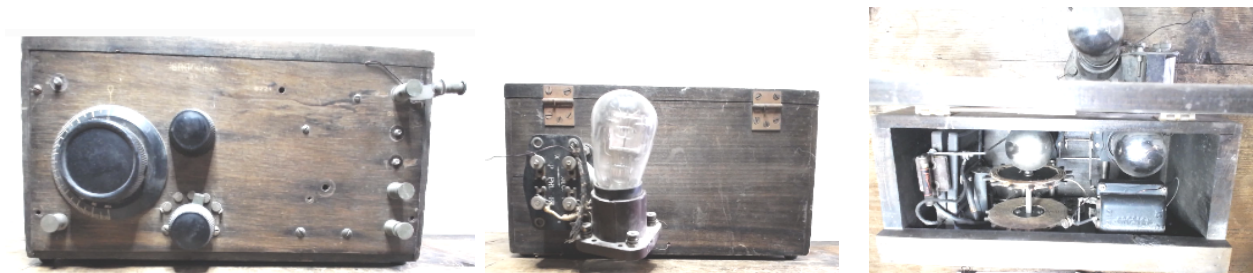
3. **Crosley 51** (serial number 148487 E): This radio is similar to that above, but there are some very distinct differences. Most obviously, the front panel is wooden rather than made of Bakelite or some similar hard substance. There is no socket for a light bulb. There is merely a hole where the label identifies the “B22+” terminal, with some scoring that indicates that this terminal was once there. All that is left of the antenna terminal is the screw sticking out of the front panel. The same is true of the output terminal and another unlabeled terminal under it. The holes are there and a screw sticking out, with the case finish darker out to a circle indicating that these terminals must have been removed relatively recently. The rheostat control seems to be entirely missing, with two holes in the front panel showing where it once must have been. The remaining capacitor, feedback and band select controls are intact and appear functional. There is one strange peculiarity on the front panel: The “B+” terminal has mounted under it a piggy-back terminal on a short piece of metal to allow a second connection to be made to that terminal. The biggest surprise, however, is a modification, presumably by a user, to add a third vacuum tube to the radio. That third tube and a transformer are mounted on the back panel outside the case, adjacent to the ½ inch hole similar to the back panel hole for battery leads of the radio above. This third tube is in a socket attached by screws to the back panel and the tube socket. The tube is very delicate, the glass envelope having lost firm contact with its base. The wiring associated with this additional stage is ad-hoc. This radio is obviously missing some things like terminals, but the biggest missing piece is the rheostat. It would appear this radio has been used as a parts source. Is the wooden front panel unique enough to make salvage of this radio worthwhile?

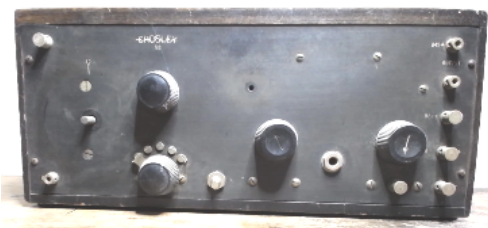
4. **Crosley 52** (serial 29356 O): This radio is a three tube model, having two stages of audio amplification. The most obvious problem, apparent immediately, is that the control knob for the “book” capacitor, used for tuning, is entirely missing. The control shaft projects out from the front panel’s surface. I didn’t see signs of a break. The large knob (marked in 0-100 graduations) detaches and can be reattached. These knobs are secured with a set screw. The terminals for “G” (Ground), “B45+,” and “Output” are missing their screw tops. This model radio has two rheostats. Both and the band selector switch and the feedback control seem mechanically functional. There is a hole on the front panel about top middle where a screw must have originally been securing the first transformer. (The screw is still present on the next radio below.) Nothing seems particularly amiss inside the cabinet. This radio does have a rear hole about ½ inch in diameter, presumably for ventilation, rather than for wires as in the third radio. The cover is a bit warped, as is true for most of the others, but more apparent in this larger radio.

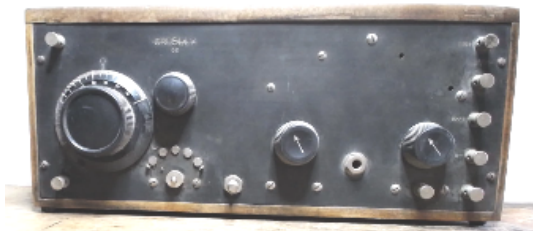
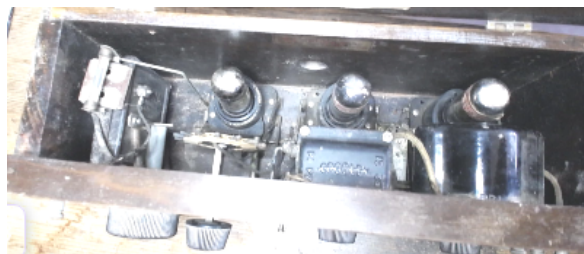
5. **Crosley 52** (serial 35594 O): This is another of the three tube model as above. This one is missing the knob for the band selector, as well as the band selector arm that makes contact with the nubs to connect at the various inductor taps. It does have the capacitor knob, though, so between these two radios a complete one should be possible. The other controls (feedback, capacitor, and two rheostats) seem functional. All of the terminal screws are present, as well as the screw missing in the middle of the front panel on the radio above. There are significant differences between this radio and the one above. In the above radio, both audio transformers appear to be identical, having the Crosley logo, and seem to be the same as the transformers found inside the Model 51 radios. For this radio, the final transformer is larger, is of different shape, and does not have the Crossley logo, at least where I could see it. There are some vacant holes in the front panel that must have originally attached the second transformer, and new screws to attach the current one. Where most of the internal wiring in the radio above is in the form of bus bars, this one mostly uses hook-up wire. Also remarkable is that all three vacuum tubes are of a different and smaller form than those of the other radios. They are cylindrical rather than larger at the top, and seem to plug into adapters that in turn plug into the original radio tube sockets. The two audio tubes have paper labels with lettering in red, “Use in last audio stage only.” The detector tube lacks that label. Again, the tubes were reluctant to be removed. I didn’t force the issue, so their identification remains a mystery at this time. They appear to be about the same size and shape as Octal “GT” tubes, perhaps slightly smaller in diameter, and longer than some.

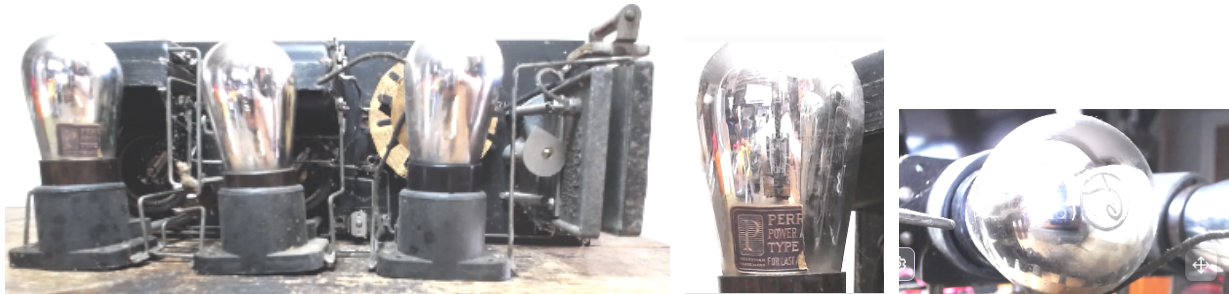
Extracting the electronics from the case is easy. The four corner wood screws are removed, and all the electronics slides out of the box along with the front panel. The tube sockets are not attached to the cabinet, nor is anything else. The bus bar circuit construction keeps the whole assembly mechanically coherent. With the electronics out of the case, an attempt was made to remove or examine the tubes, but they still are not inclined to move. The second audio amplifier has a bit of its label remaining. Something that may have been a logo, a script "C" (for Crosley?) was found on the crown of the detector, but neither of the other tubes.

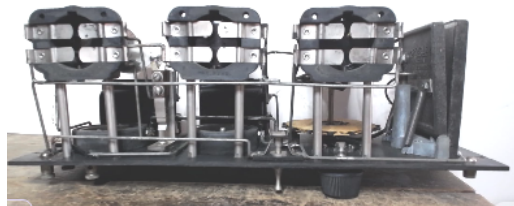
With power off and no attachments, component values were measured with an Extech LCR Meter (model 380193) at both 120 Hz and 1 KHz. For the transformers coils DC resistance was also measured with a METEX 4650CR DVM.

Filament circuits: The off/on switch resistance, initially 3.7 Ohms, was worked a bit and later registered .19 Ohms, considered acceptable. With both filament pots off, 726 K Ohms was measured across the A supply. Rotating the detector supply pot (only) gave inconsistent and high readings, reaching a low of 38 Ohms at about 80% rotation. Leaving it open and rotating the audio pot also gave inconsistent high readings but reaching a low of 107 Ohms. Clearly both potentiometers need work to restore them to proper operation.

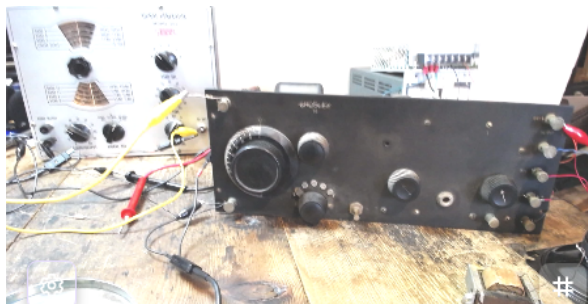
A signal generator is available to supply 400 Hz modulated RF at various frequencies, an EICO model 324. This same signal generator has been used for previous radio work and seems to be reasonably accurate, within a percent or so, for frequency. The output is not very symmetric, generating higher harmonics. Still, the instrument should be sufficient for making basic observations. In the past a resistor of about 1 Meg was used in substituting for a signal from the antenna. The oscilloscope used is a Tektronix 465B analog two channel (chopped) oscilloscope. Times 10 probes were used. The set-up is shown in the picture below. (The oscilloscope is below the table.)
